**EP 1 286 020 A2**

### (54) Method for repairing an apertured gas turbine component

[0001] The present invention is directed to repairs of a coated gas turbine component, and more particularly, to repairs of defects in an air-cooled gas turbine vane having diffusion cooling holes where the vane is coated with a thermal barrier coating (TBC) system.

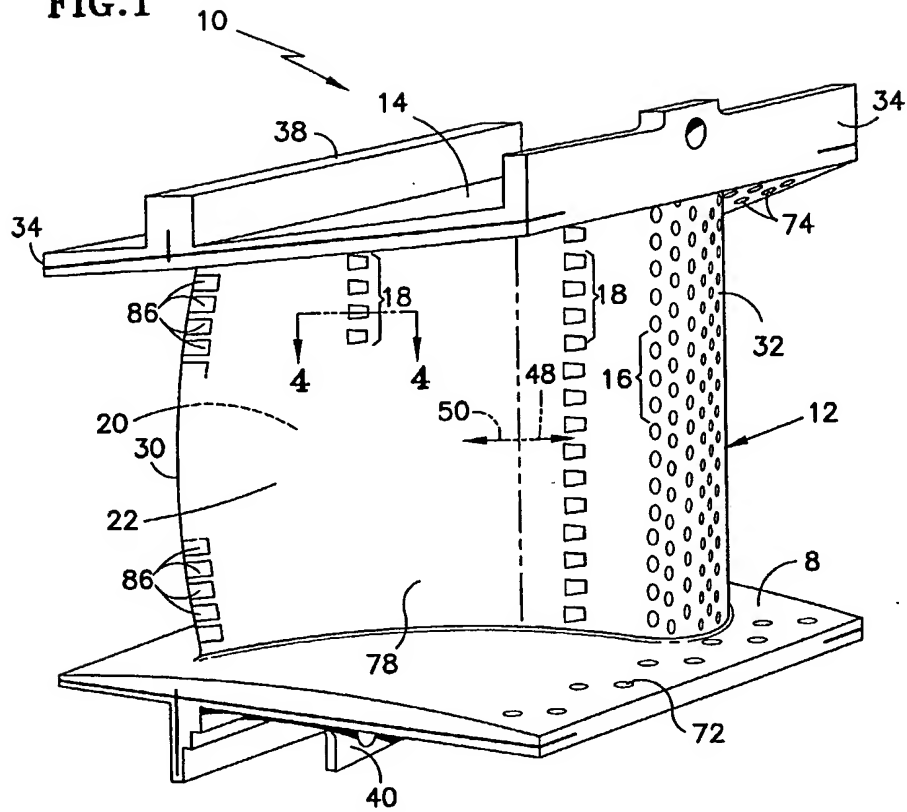
FIG.1

Fig. 1 is a perspective view of a typical gas turbine engine high pressure turbine vane;

[0025] Referring to Fig. 1, a high pressure turbine vane (article) 10 is shown. Referring also to Figs. 2 and 3, a top view and a bottom view are respectively shown for the vane 10 of Fig. 1. The vane 10 comprises an airfoil section (airfoil) 12 having at least one internal cavity 24 (Fig. 2), the internal cavity 24 having an internal surface 26 (Fig. 2). The airfoil section 12 has a convex surface 20 and a concave surface 22. The convex and concave surfaces 20, 22, respectively, are bounded by a trailing edge 30 and a leading edge 32 and together form an exterior surface 78 of the airfoil. The exterior surface 78 is exposed to the hot gas path. The trailing edge 30 of the airfoil 12 includes cooling slots 86. Also, the airfoil section 12 is bounded by an inner diameter platform (platform) 8 and an outer diameter platform (platform) 14. The inner and outer diameter platforms 8, 14 create the gas path annulus and include cooling holes 72, 74, respectively. The outer diameter platform 14 includes opposing flanges 34, at least one cover 36 (Fig. 2), preferably two, and a rail 38. The inner diameter platform 8 includes a rail 40 and a cover 42 (Fig. 3), preferably two.

[0027] The vane 10 lies in the hot gas path and the vane 10 is air-cooled by flowing cooling air, typically from the compressor discharge, into the internal cavities 24. Cooling air enters the internal cavities 24 through corresponding openings in the platforms 8, 14. This air cools the internal surface 26 of the airfoil 12 by convection or internal baffle impingement and cools the convex and concave surfaces 20, 22, respectively, of the airfoil 12 by film cooling. The air is directed from the internal cavities 24 and outward across the vane 10 by a plurality of cooling holes, preferably cylindrical cooling holes 16 and diffusion cooling holes (diffusion holes) 18, to help it withstand the high temperatures to which it is exposed. The cooling air is also directed across the platforms 8, 14 upon exiting the respective cooling holes 72, 74. The trailing edge 30 is cooled by air exiting through the slots 86.

[0028] Although Fig. 1 shows the plurality of cooling holes 16, 18 located on the concave surface 22, it is readily understood by those skilled in the art that the plurality of cooling holes 16, 18 are formed on both the convex and concave surfaces 20, 22, respectively.

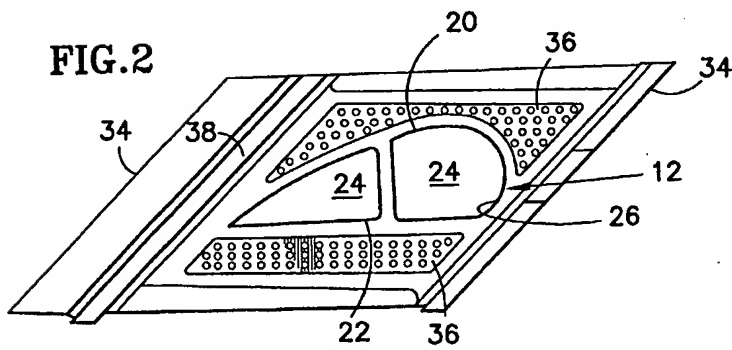
FIG.2

Fig. 2 is a top view of the vane of Fig. 1;

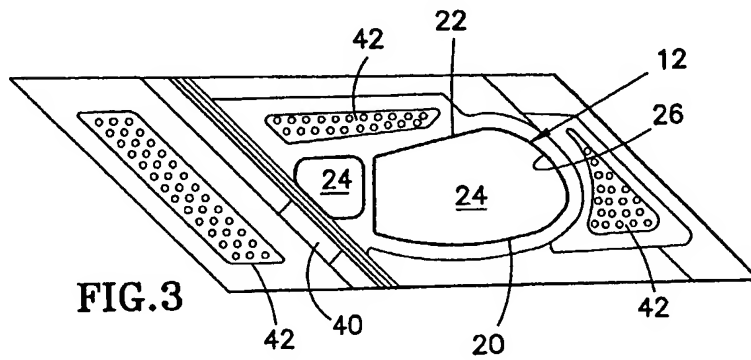
FIG.3

Fig. 3 is a bottom view of the vane of Fig. 1;

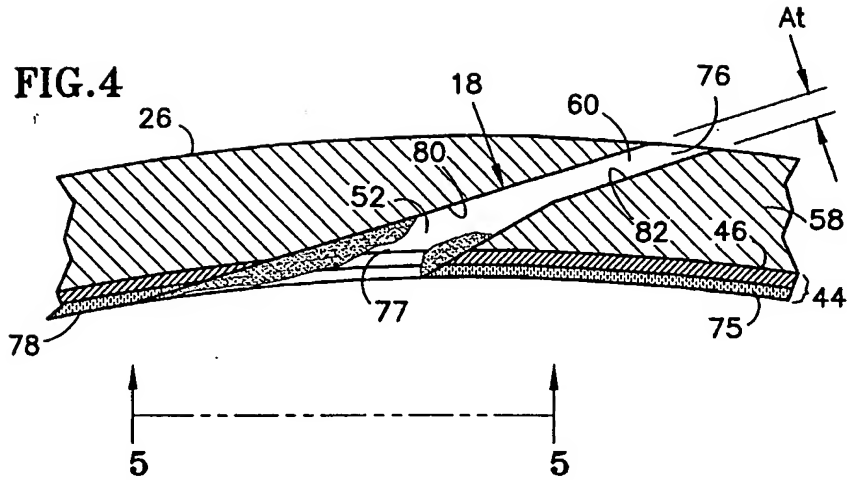
FIG.4

Fig. 4 is an enlarged cross-sectional view taken essentially in the direction 4-4 of Fig. 1 and illustrating the vane substrate, an existing protective coating applied to the substrate and a typical diffusion cooling hole extending through the substrate and the coating;

[0029] Referring to Fig. 4, a cross-sectional view of the wall thickness of the airfoil 12, and in particular the diffusion hole 18, is shown taken along the line 4-4 of

[0031] Referring now to Figs. 1 and 4, it is noted that the vane 10 has a plurality of diffusion holes 18 which may have various geometries and predetermined air flow characteristics based on location within the vane 10. The representative diffusion hole 18, shown in Fig. 4, has a metering passage 60 in fluid communication with a diffusion passage (mouth) 52, each having a predetermined geometry. The metering passage 60 has an inlet 76 with a predetermined throat area, shown as  $A_t$ , where the throat area  $A_t$  provides a predetermined air flow requirement. Thus, the inlet 76 regulates cooling air flow into the diffusion holes 18 from the internal cavities 24. The diffusion passage 52 is axially diverging, nonregulatory and extends from the inlet 76 to an outlet 77 at the exterior surface 78 of the vane 10. The diffusion passage 52 facilitates the film cooling of the exterior surface 78 of the airfoil 12 as the cooling air exits from the diffusion passage 52 of the diffusion hole 18. The diffusion passage 52 also includes an inner shaped portion (inner diffuser portion) 80 while the metering passage 60 includes an inner metering portion 82.

[0048] Referring now to Figs. 1, 4 and 5, diffusion holes 18 located in region 50 may require reworking. The application of the nonoriginal metallic bond coat 46 to the entire surface 78 of the vane 10 may result in a quantity of excess bond coating accumulating in the diffusion passage 52 of the diffusion holes 18 thus reducing the area through which the cooling air passes. Since this "coatdown" phenomena, as shown in Figs. 4 and 5, affects most, if not all of the diffusion holes 18 in region 50, the effectiveness of the cooling medium is diminished and the vane's durability is compromised. The coatdown phenomenon is normally not a problem during the manufacture of original equipment vanes since the protective coatings, and in particular, the metallic bond coat, are usually applied prior to installation of the cooling holes.

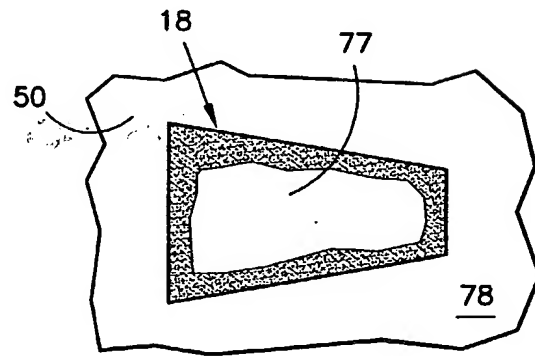
FIG.5

Fig. 5 is a view taken essentially in the direction 5-5 of Fig. 4 showing the diffusion hole prior to the repair of the present invention;

Fig. 1. Fig. 5 shows a view taken essentially in the direction 5-5 of Fig. 4 showing the diffusion hole 18 prior to the repair of the present invention.

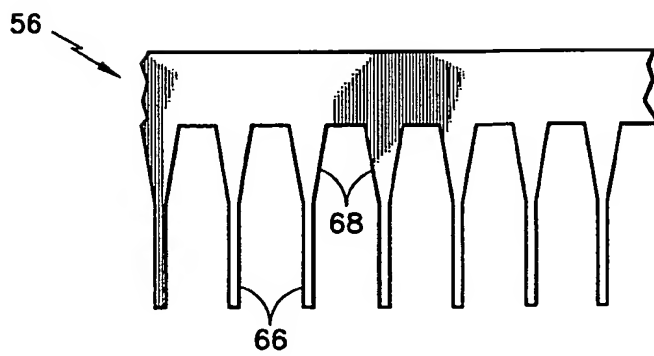
FIG.6

Fig. 6 is a side view of an electrode suitable for use with the repair method of the present invention; and

[0051] Referring to Figs. 6 and 7, electrodes 56, 62 suitable for insertion into an electric discharge machining device are shown. Referring to Figs. 1, 4, 5 and 6, the remanufacture and repair of the diffusion holes 18 in local regions 48, 50 of vane 10 using electrodes 56, 62, respectively, will now be described.

[0052] The electrode 56 includes a metering portion 66 and a diffuser portion 68. The electrode 62 includes a diffuser portion 70. It is noted that the geometry of the individual electrodes 56, 62, specifically the respective portions 66, 68, 70, are preselected to correspond to the required shape of the corresponding diffusion hole 18 to which it is used. In particular, the electrode 56 is chosen to restore the inner diffuser portion 80 and inner me-

[0054] In local region 48, the diffusion hole 18 is now remanufactured using the electrode 56. Since the repair material filled the diffusion hole 18, both the metering portion 66 and diffuser portion 68 of the electrode 56 are required to effect the remanufacture. The diffuser portion 68 of the electrode 56 corresponds in shape to the diffuser passage 52, and more specifically, the inner diffuser portion 80, of the diffusion hole 18. While, the metering portion 66 of the electrode 56 corresponds to the metering passage 60, and more specifically, the inner metering portion 82 of the diffusion hole 18.
